ДЕТАИЛ 3  
DETAIL 3  
М 1:25  
КОЖУХ - ПРЕМИНАВАНЕ ПРЕЗ СТЕНА  
HOOD-PASSING THROUGH A WALL

ВЕРТИКАЛЕН МОНТАЖ НА СЪЛЪБА  
SAFETY LADDER - VERTICAL INSTALLATION

MINISTRY OF ENVIRONMENT AND WATER  
Directorate "European Union Funds for Environment"  
ISPA Measure No 2002/BG/16/P/PE/018

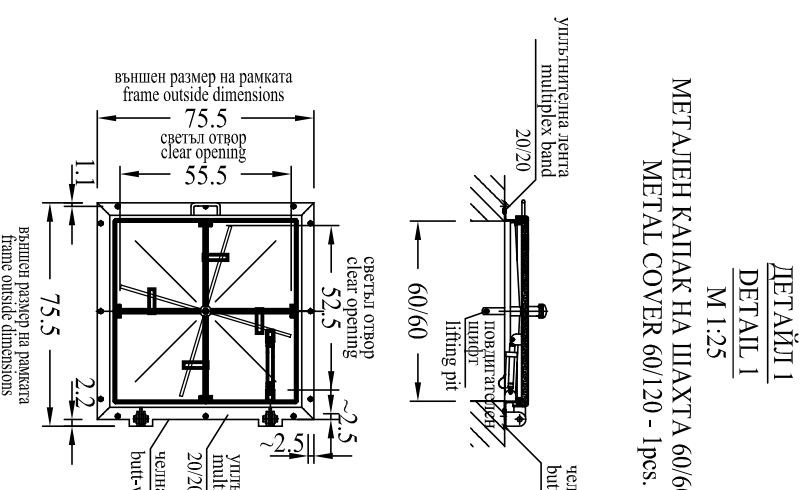
МЕТАЛЕН КАПАК НА ШАХТА 60/60 - 25PC  
METAL COVER 60/120 - 1pc.

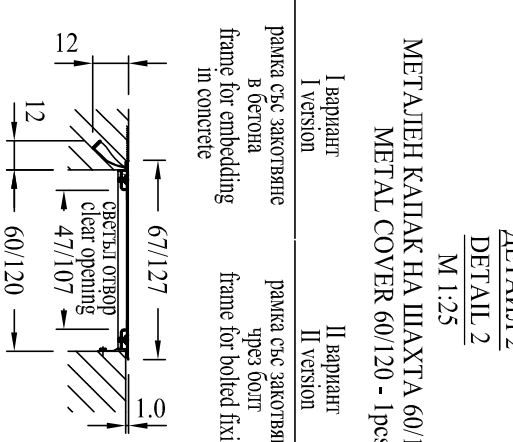
DETAIL 2  
M 1:25  
METALLEN KAPPAK HA SHAXTA 60/120 - 16P  
METAL COVER 60/120 - 16ps.

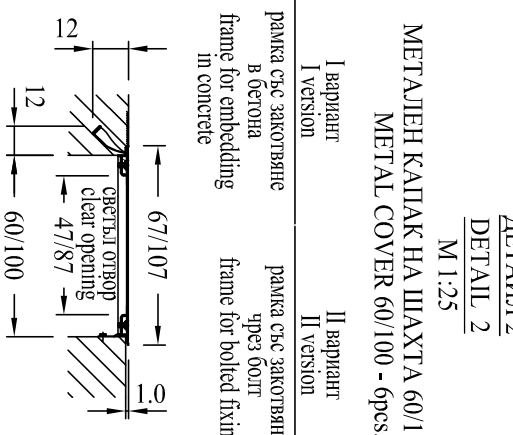
МЕТАЛЕН КАПАК НА ШАХТА 60/100 - 65Р.  
METAL COVER 60/100 - 65P.

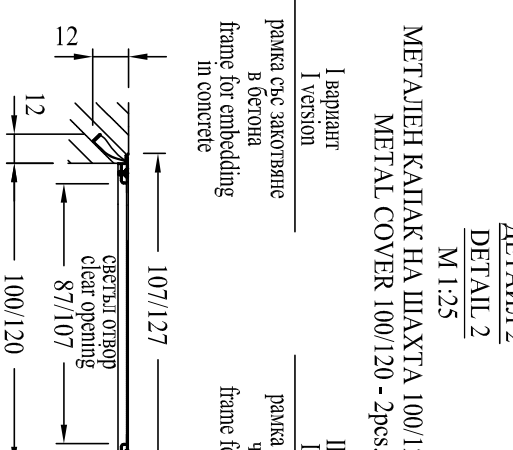
DETAIL 2  
M 1:25  
METALJEH KATIÄK HA HAXTA 100/120 - 2BP  
METAL COVER 100/120 - 2pcs.

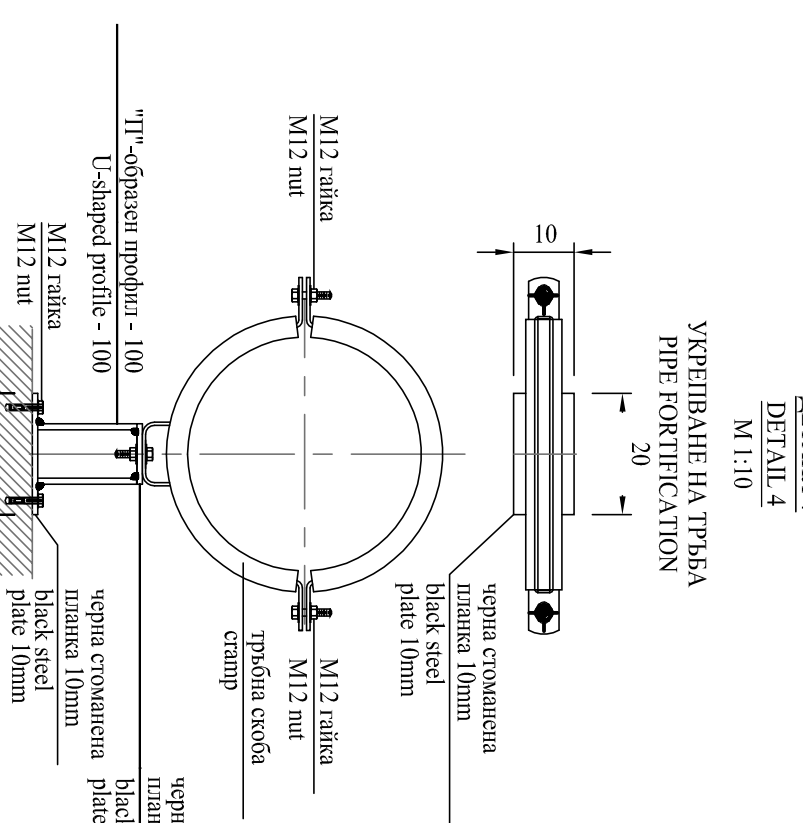
DETAIL 4  
M 1:10  
УКРЕПБАНЕ НА ТРБСА  
PIPE FORTIFICATION  
20

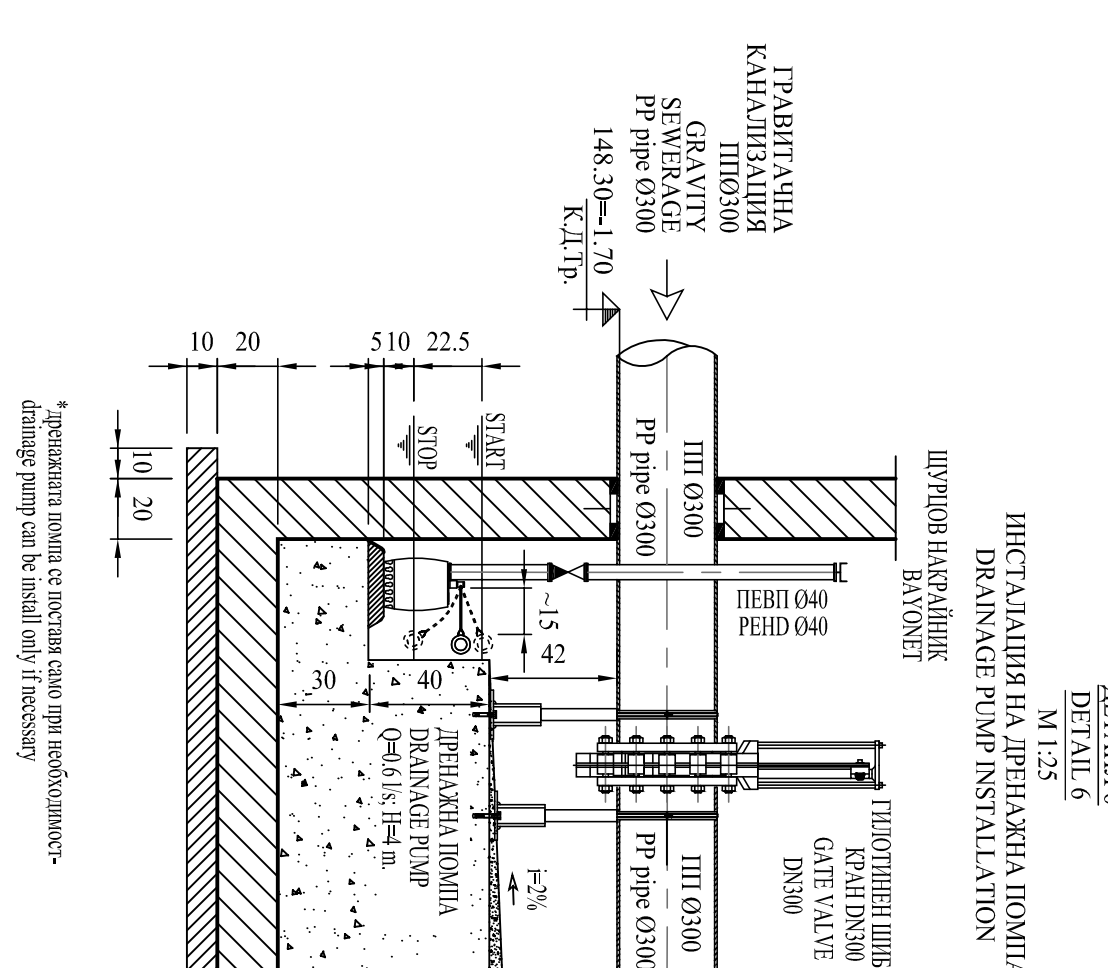
DETAIL 6  
M 1:25  
УСТАНОВКА НА ПУМПА

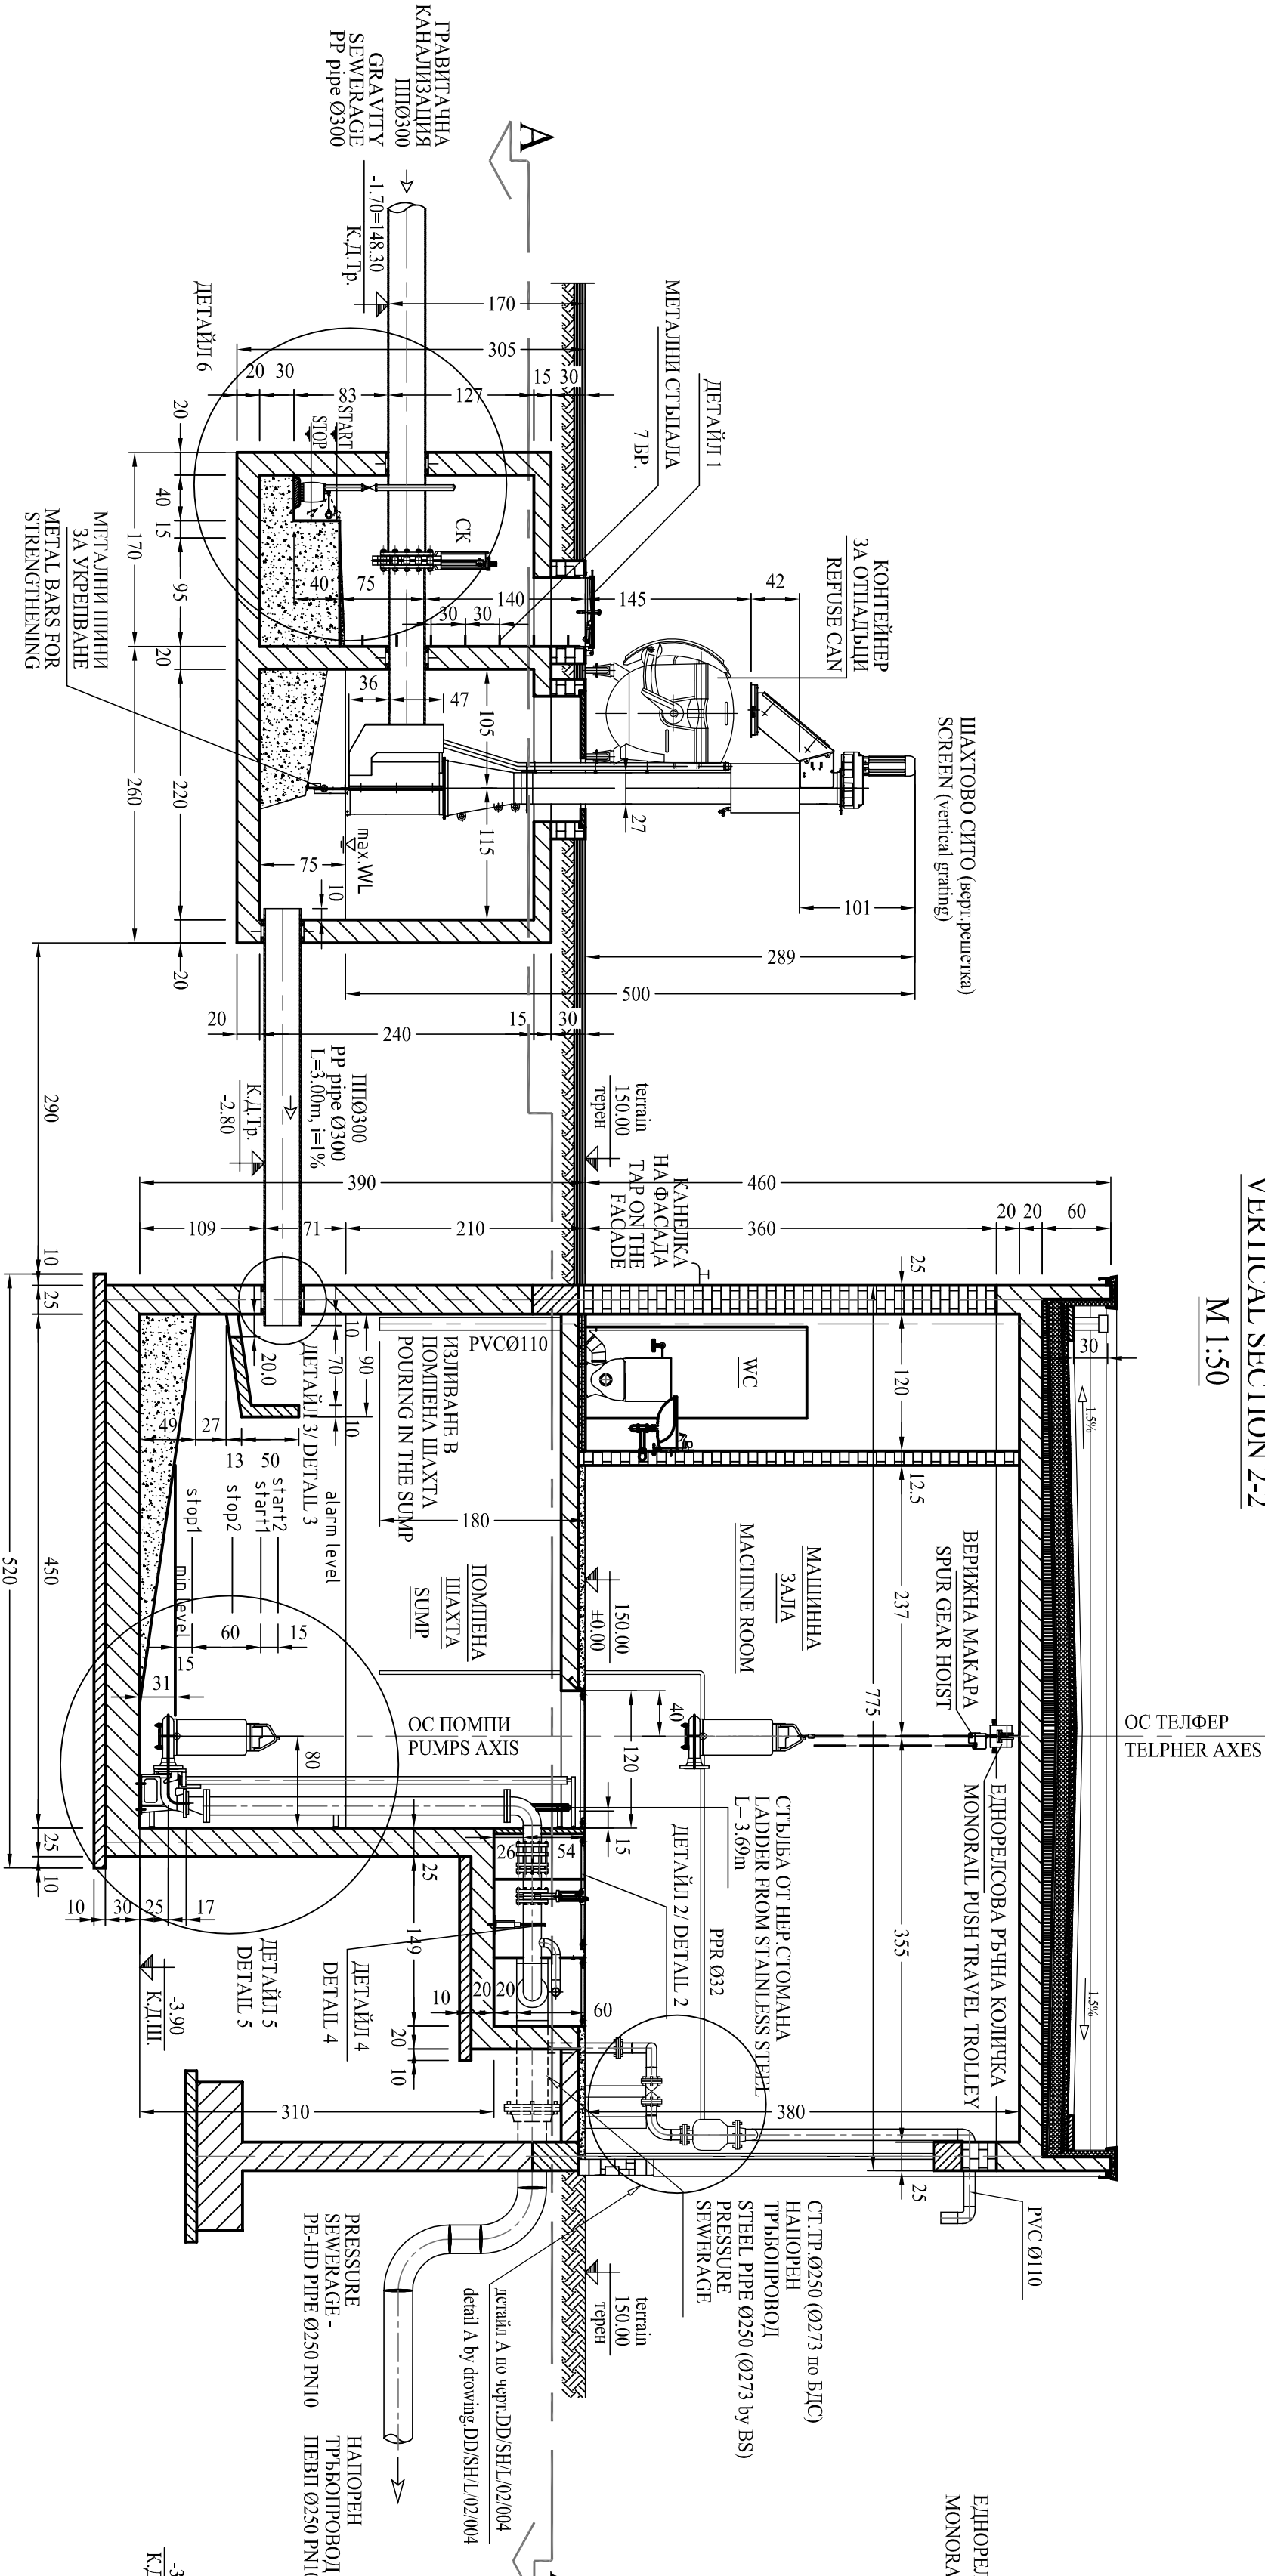
БЕРТИКАЛЕН РАЗРЕЗ 1-1  
VERTICAL SECTION 2-2  
M 1:50

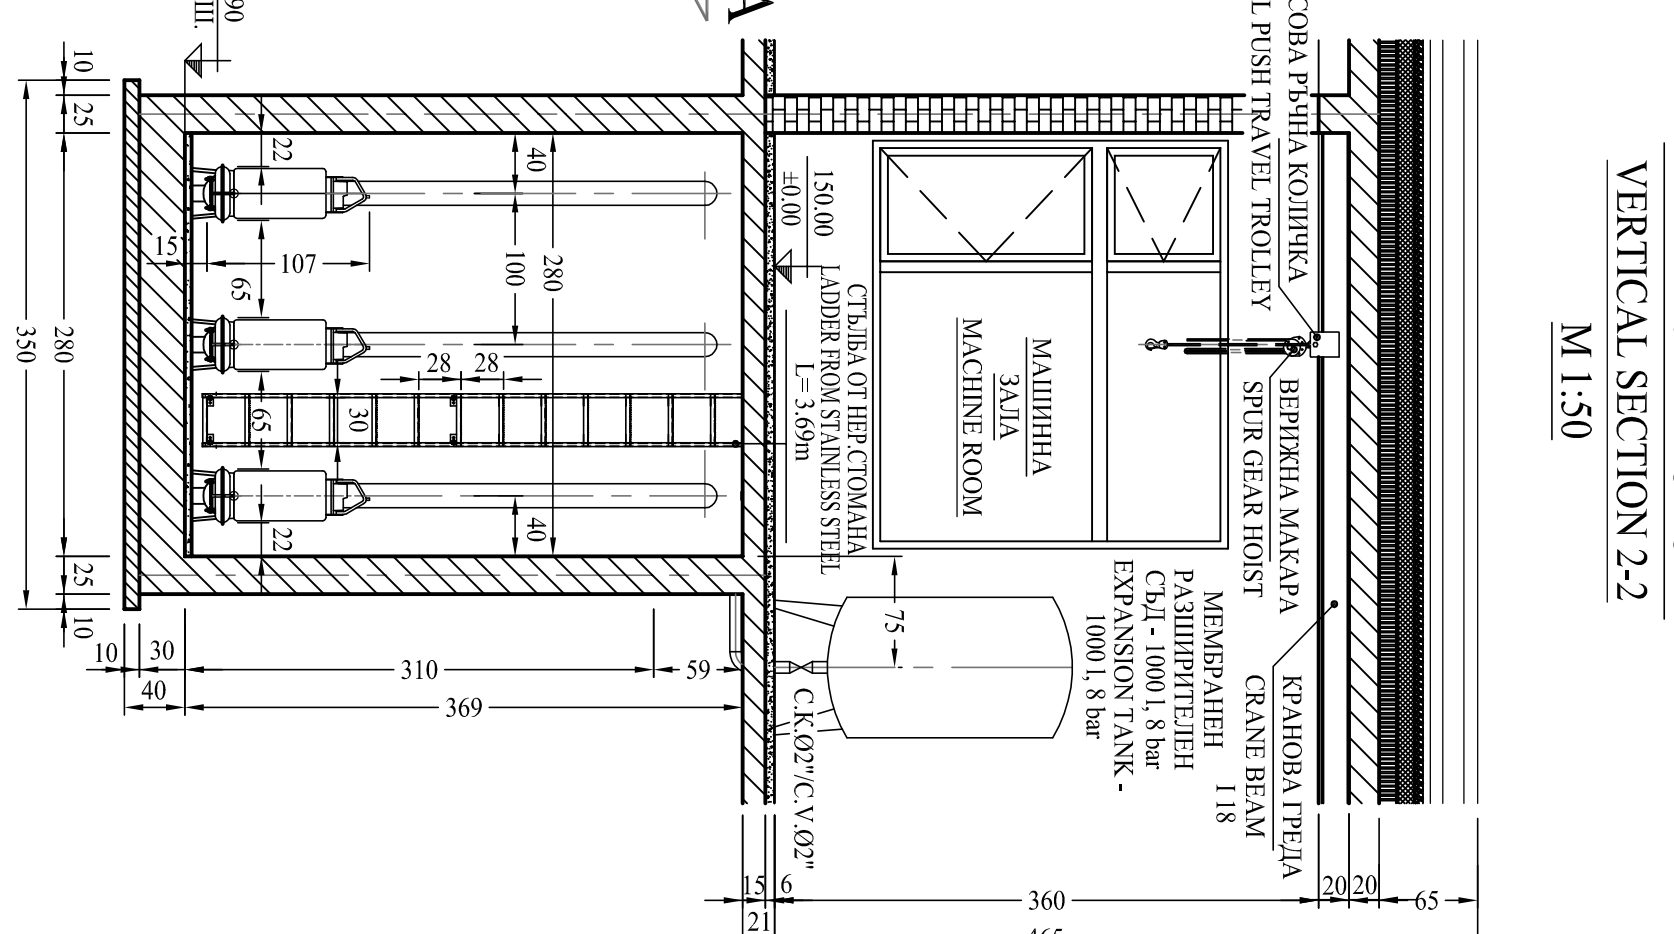
VERTICAL SECTION 2-2
